**URA Project K1 Nga Tsin Wai Village redevelopment (NTW)  
Report on Protective Works for Excavated Remains**

Archaeological Assessments Limited  
August 2021

TITLE OF THE REPORT  
URA Project K1 Nga Tsin Wai Village redevelopment (NTW)  
Report on Protective Works for Excavated Remains

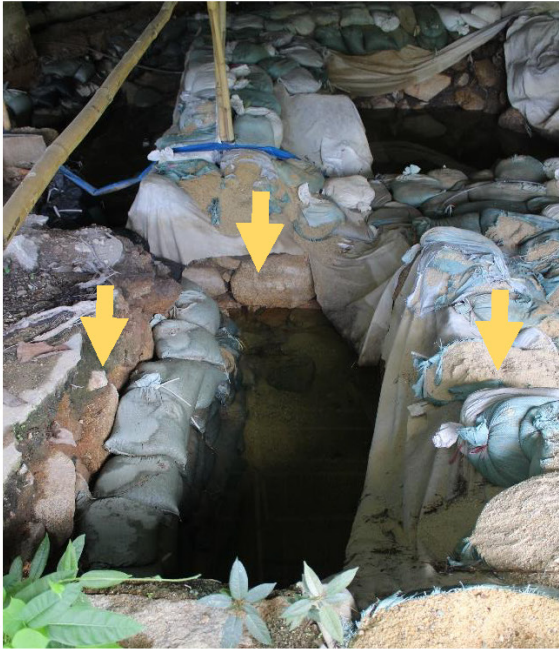
Plate 1 Split sand bags, exposed stone walls and sections not completely supported by sandbags in Trench 1

1. Firstly, the debris, damaged or worn sandbags and worn geotextile coverings from site were cleared. The stability of the remnants as well as the upper sandbags, if applicable, were taken into account when replacing them;

2. A new layer of geotextile covering, where necessary, was installed over the Nga Tsin Wai structural remains and features; followed by a minimum of three rows of sandbags or its equivalent in clean sand placed over the geotextile;

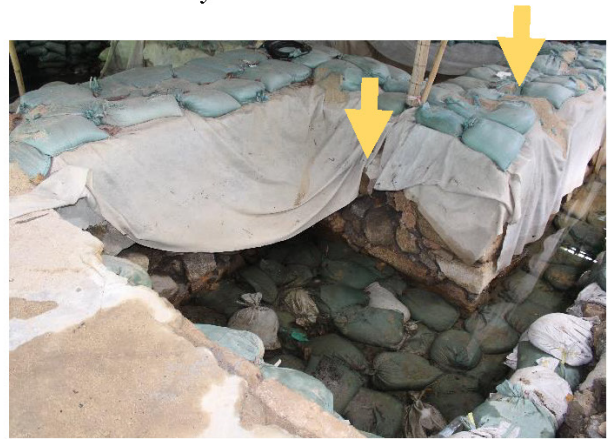
Plate 2 Split sand bags and exposed stone walls in Trench 3

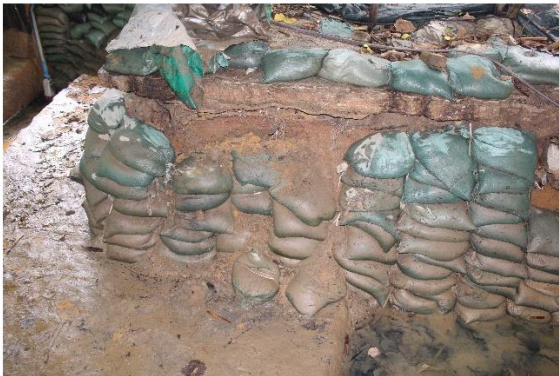
Plate 3 Exposed sections in Trench 7

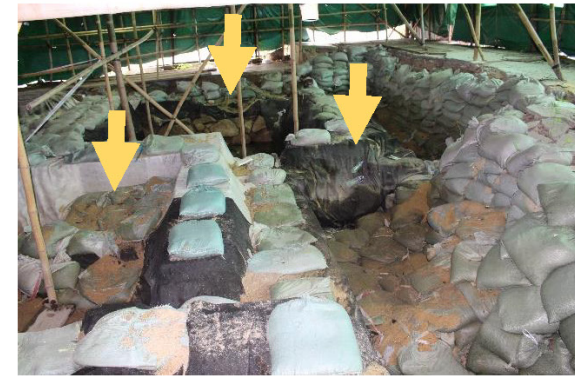
Plate 4 Split sand bags over the brick floor, uncovered stone walls and rubbish in Trench 9
